1. RESERVE STUDY EXECUTIVE SUMMARY

Client: Villages of Westcreek Owners' Association, Inc. (Villages of Westcreek)

Location: San Antonio, Texas

Reference: 161959

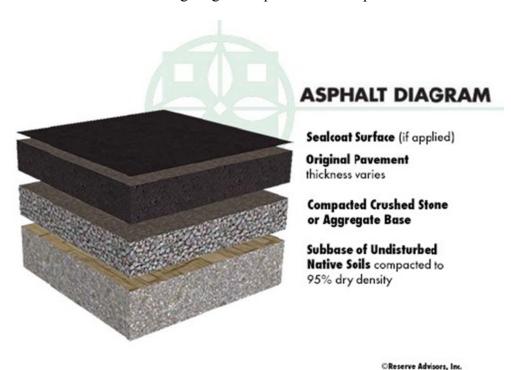
Components of asphalt pavement include native soil, aggregate and asphalt. First the contractor creates a base course of aggregate or crushed stone and native soil. The base course is individually compacted to ninety-five percent (95%) dry density prior to the application of the asphalt. Compaction assures a stable base for the asphalt that reduces the possibility of settlement. Driveway and access drive pavement is typically constructed with a compacted base and a single course of asphalt pavement. As such, the pavement is subject to greater wear from vehicle traffic and erosion. The following diagram depicts these components:

The manner of repaving is either a mill and overlay or total replacement. A mill and overlay is a method of repaving where cracked, worn and failed pavement is mechanically removed or milled until sound pavement is found. A new layer of asphalt is overlaid atop the

remaining base course of pavement. Total replacement includes the removal of all existing asphalt down to the base course of aggregate and native soil followed by the application of two or more new lifts of asphalt. We recommend mill and overlayment on asphalt pavement that exhibits normal deterioration and wear. We recommend total replacement of asphalt pavement that exhibits severe deterioration, inadequate drainage, pavement that has been overlaid multiple times in the past or where the configuration makes overlayment not possible. Based on the apparent visual condition and configuration of the asphalt pavement, we recommend the mill and overlay method of repaving at Villages of Westcreek.

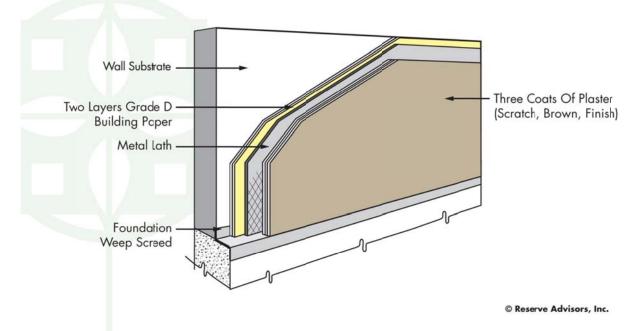
STUCCO DETAIL

Along with proper installation, proper maintenance and periodic finish applications, the inherent composition of stucco wall systems results in an indefinitely long useful life. The useful life of these finish applications is from 8- to 10-years. We recognize that the initial finish may achieve a longer useful life. Color variations at repairs often warrant complete coating application to maintain aesthetics. Periodic repairs and finish applications help prevent water infiltration and spalling from weather exposure, maintain a good appearance and maximize the useful life of the system. We include the following commentary as a summary of the minimum requirements for a successful paint finish application for present and future board members.

Correct and complete preparation of the surface before application of the paint finish maximizes the useful life of the paint finish and surface. The contractor should remove all loose, peeled or blistered paint before application of the new paint finish. The contractor should then
